STEAM LOCOMOTIVE SERVICES, INC.

REPORT ON DELAWARE & HUDSON GRAVITY RAILROAD COMBINATION FREIGHT & PASSENGER CAR

This report, prepared November 9, 2001 covers my inspection of the former Delaware & Hudson Gravity Railroad combination freight and passenger car owned by the Carbondale Historical Society and Museum, Inc. whose offices are located at One North Main Street, Carbondale, Pennsylvania 18407. The inspection was conducted with the assistance of the organization's Executive Director, Mr. Robert Powell at the Homestead Golf Course where the car is stored on September 10 & 11, 2001. Photographs taken at this time are enclosed and identified in attachment - A.

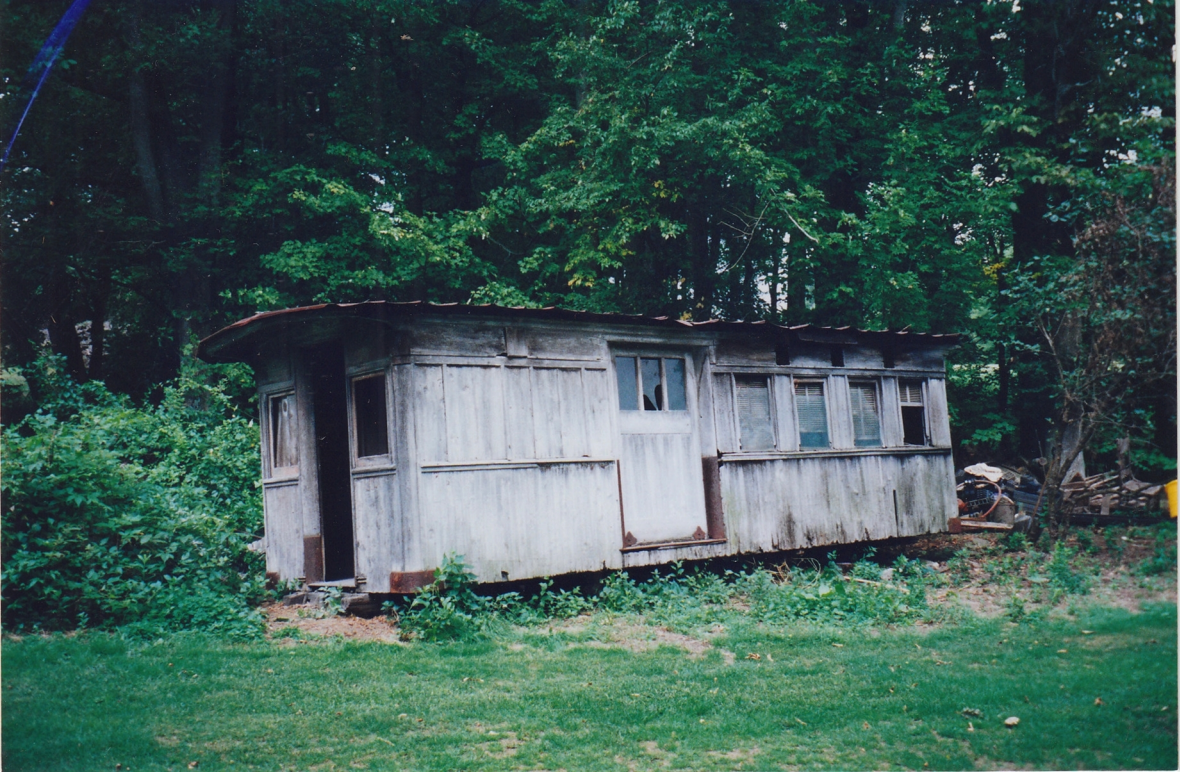
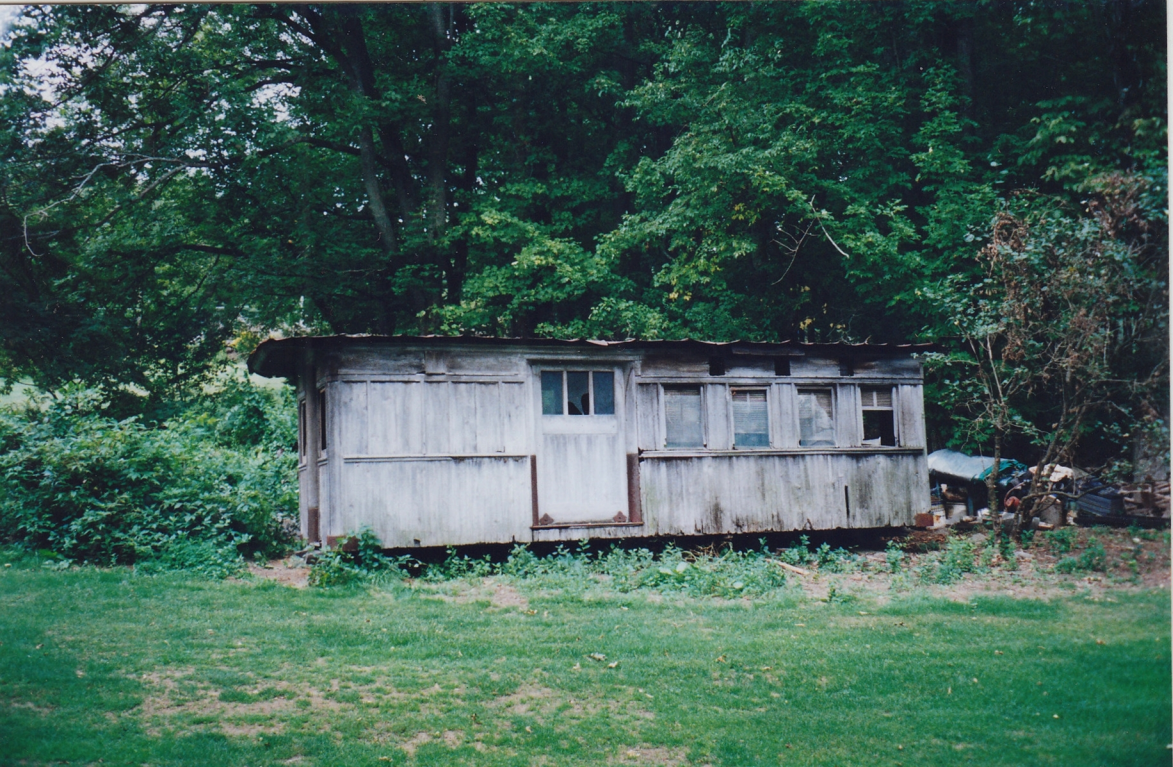
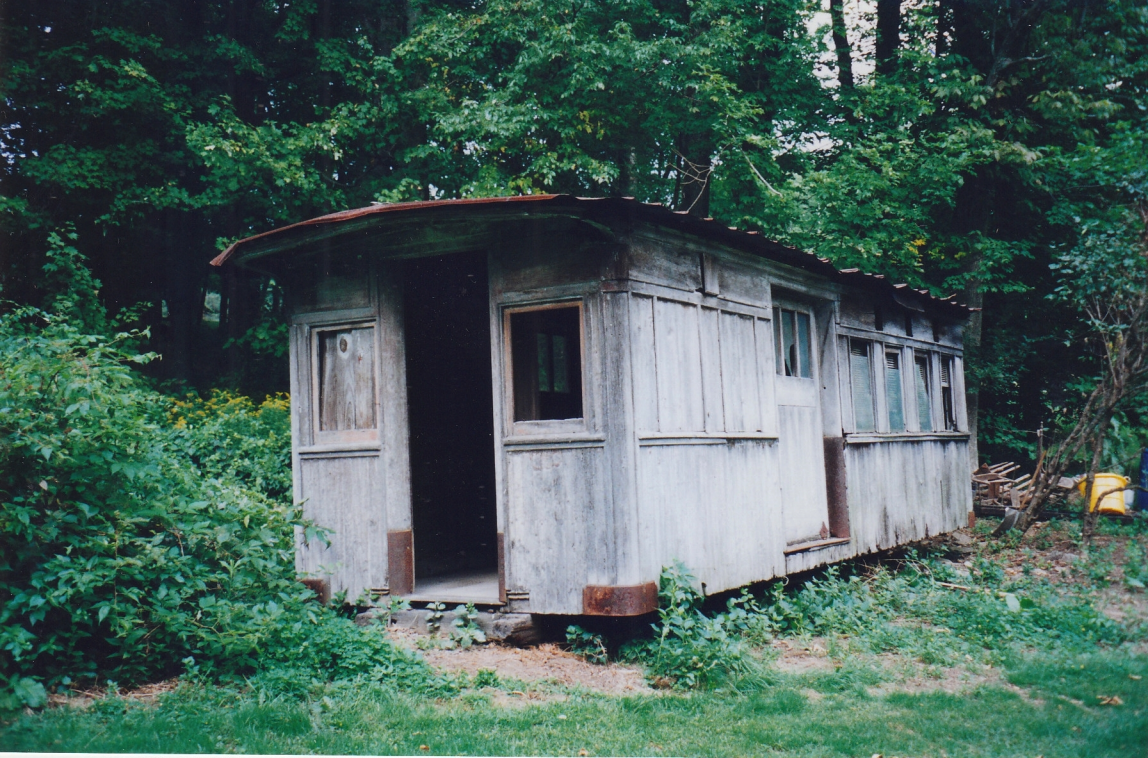
Number	Description
1-3	Exterior, left side
4-5	Exterior, right side
6	Baggage end
7-9	Baggage door and details, left side
10	Belt rail detail, right side
11-12	Window and sill details, left side
13-14	Outer vent cover and outer vent opening, left side
15-19	End hood details, both ends, both sides
20	Mounting bracket for unknown object, under passenger end hood
21	Passenger end detail
22	Passenger end door
23-24	Passenger end window details
25-28	Car frame details as seen from trench dug under car
29-31	Car interior views
32-34	Baggage end interior details
35-37	Car interior details of window and blinds
38	Interior ceiling
39-40	Interior baggage door and track details
41	Detail of interior roof bows with ends rotted and ventilator
42	Detail of ventilator
43	Detail of floor showing damaged section
44	Detail of floor showing where baggage door guards were mounted
45	Detail of interior where paint was sanded to reveal layers

Left side: Replace all exterior wood including tack moldings, letter board cap strip, letter board, battens and boards, window sills, belt rail, siding and four sash. Note that once this wood has been carefully removed for use in making replacements it is likely that interior framing will be found to be in need of replacement or repair as well. Also note that some sections of siding removed may be useful for patching other areas.

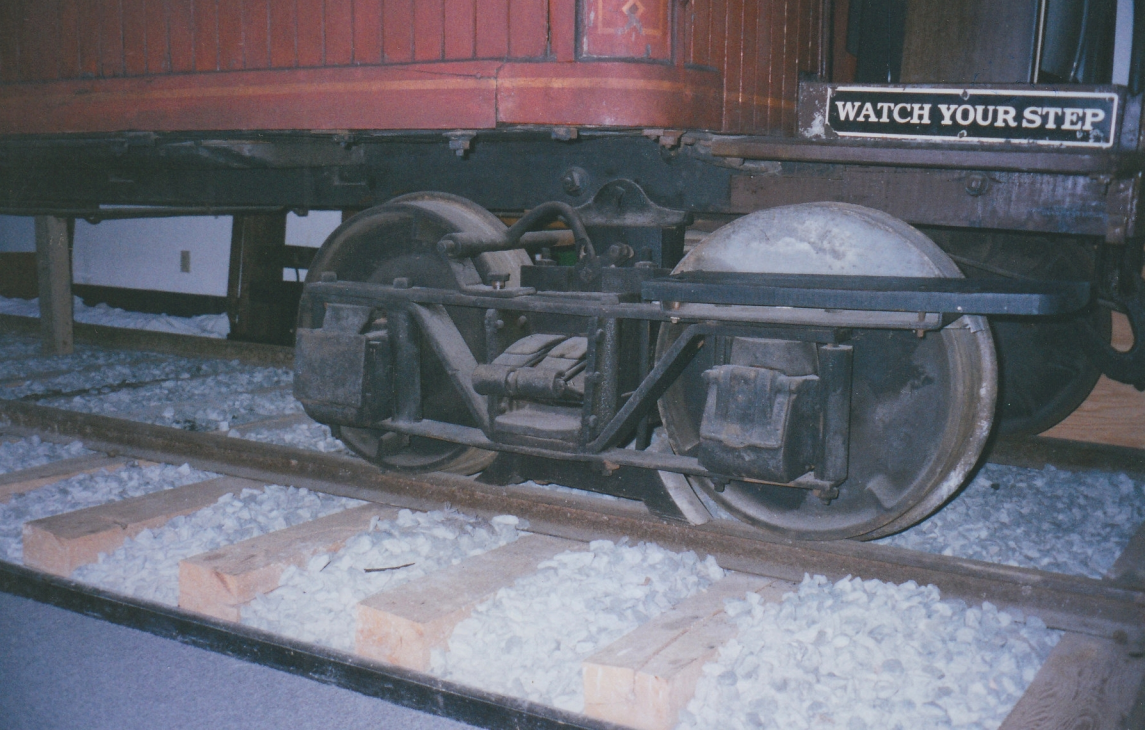
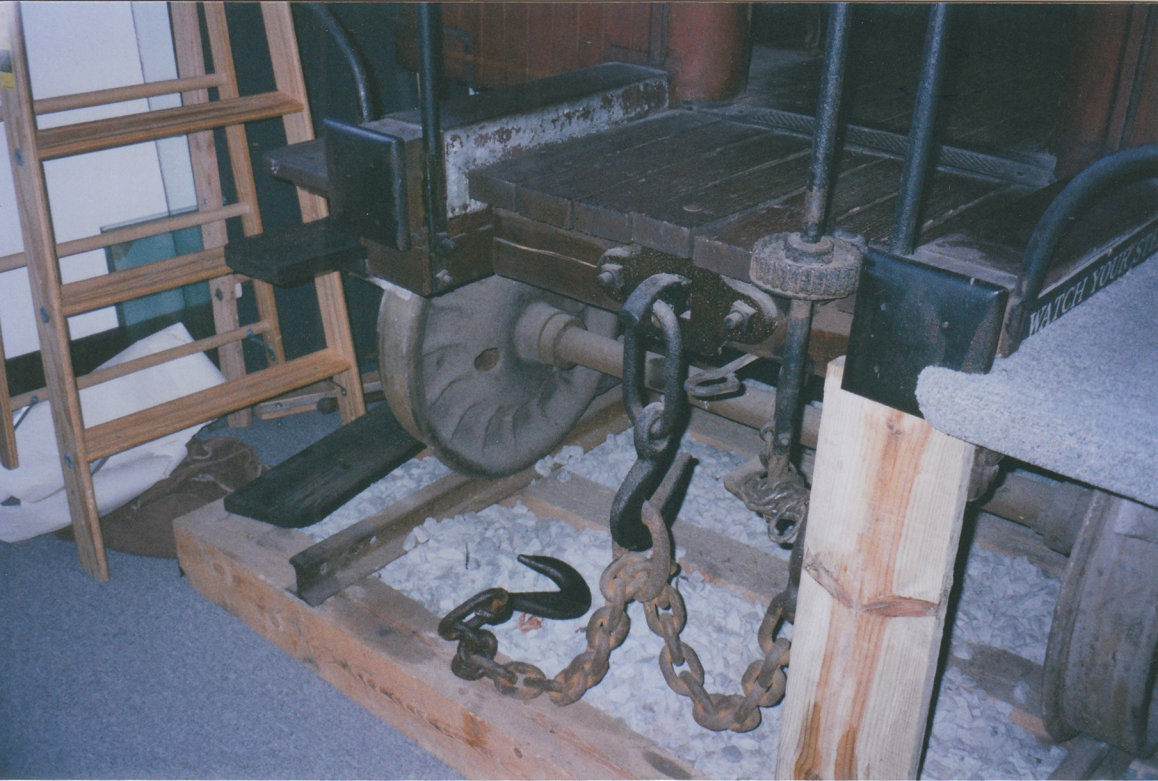
46-47	Details of car No. 9 "trucks" and platform, coupling, and brakes

The "trucks" would be very difficult and expensive to reproduce. A set exists under car No. 9, which could be used as a guide for manufacture. However the cost of making these would be possibly as much as \$50,000.00 therefore it is not recommended that these be made at this time. The end platforms, couplers, etc. and could be made, using the parts of car No.9 as a guide. Thus far, no outer ventilator cover has been found, and photographs do not show them clearly. It may be necessary to guess as to their appearance. The inner
